CASE STUDY

Application: Property Management Balcony Solutions

Product: Covered Molded Grating and Customized Dynarail® Handrail System

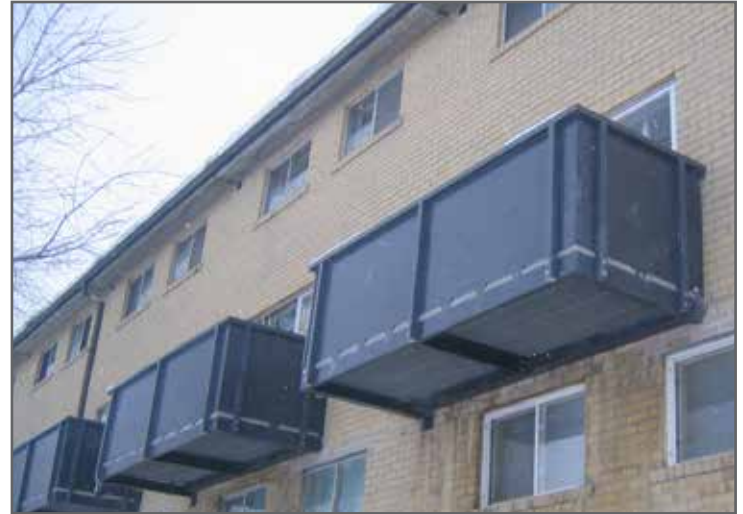
The existing balconies, both single and double-sized, consisted of a solid cement slab base and steel barriers/handrails. This type of construction made it difficult for accumulated rainwater and melted snow to properly drain and resulted in water damage and unsightly stains on the brick exterior of the buildings. Additionally, the steel barriers and handrails were prone to rust and required routine sanding, repainting and inevitable replacement.

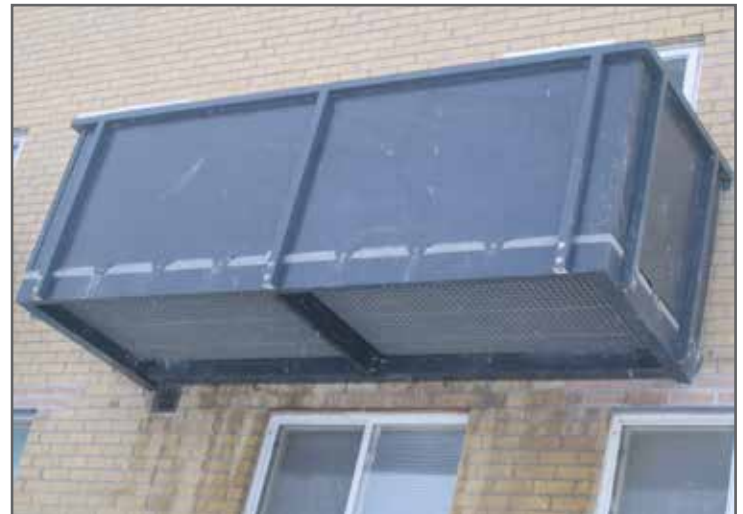
After considering all of the structural and environmental factors, Fibergrate recommended a complete replacement of all 62 existing balconies. The Fibergrate solution involved the installation of a covered FRP grating base and a customized FRP handrail system. To address the drainage issues, small slots were included around the perimeter of the base. The doubled-sized balconies were given privacy separation with an FRP divider. The new FRP balconies give the apartment buildings a clean and fresh appearance, while also being virtually maintenance-free. The property management company is very pleased with the end result and has since contracted Fibergrate to replace the balconies on other properties.
