CASE STUDY

Application: Staircase Solutions for Residential Townhouse Complex

Product: Covered Stair Treads with WLP Hold Down Clips

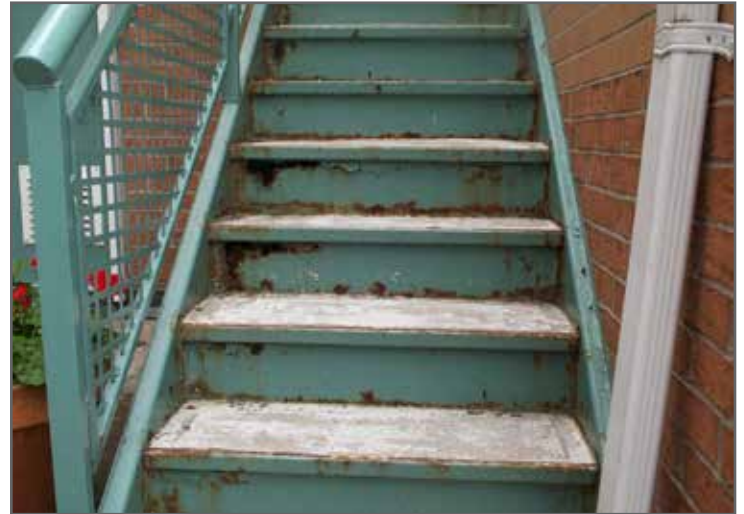
Before

One of the residential townhouse complexes managed by this company was experiencing difficulty with the entrance steps to the home owners units. The steps were made of concrete in a steel pan. These stairs are replaced every 2- 3 years as the concrete crumbled in chunks, creating both a safety and aesthetic issues for the condominium complex.
