CASE STUDY Architectural & Commercial

Location: Scottsdale, Arizona **Application:** Rooftop Pool Deck

Product: Micro-Mesh® Molded Grating and Bison Grating Pedestals

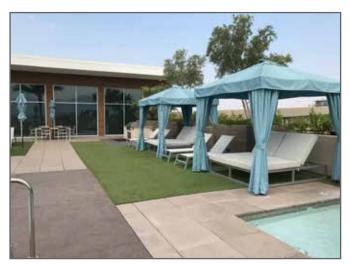
A flooring system was needed to support the turf around the rooftop pool. The landscape architecture firm that designed the pool deck searched for a specific material to use as a flooring system that needed to be lightweight in order to avoid any damage to the rooftop. The grating had to be able to drain the water splashing from the pool, from wet feet, and rain water. The decking materials needed to be able to withstand chlorine and other chemicals in the water.

With the help of Fibergrate's territory manager, the landscape architecture firm decided to use Micro-Mesh® molded fiberglass reinforced plastic (FRP) grating with a meniscus surface and Bison grating pedestals. The pedestal design provides sturdy support for this flooring system. The open area in this grating will allow the water to flow through the turf and grating. The lightweight properties allowed for an easy installation and will help keep the rooftop in excellent condition for years to come. Additionally, the corrosion resistant FRP will save the customer time and money due to reduced maintenance and long product life.
